Chaetura

SPRING 2000

Driftwood Wildlife Association

Combining Habitat Construction with Education

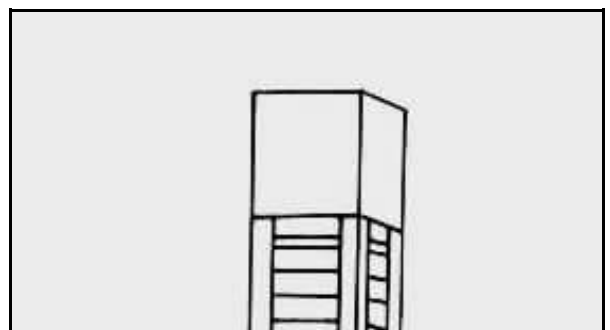
Soon after the first of the year we began construction of 2 new Chimney Swift Towers at the Hornsby Bend Wastewater Treatment Plant near Austin, Texas. With funding from the Travis Audubon Society and cooperation from the Center for Environmental Education and the City of Austin we combined

the Center for Environmental Education and the City of Austin we combined Chimney Swift housing with public education.

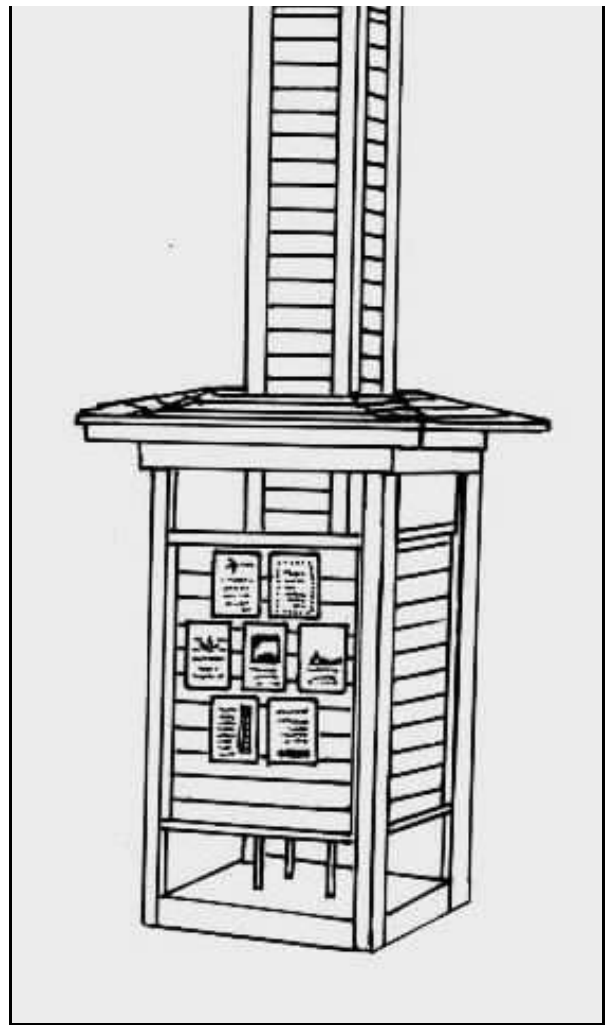
The nest chambers were based on our time-tested 12' towers built of Textured 1-11 siding. Both included a space between the inner wall and outer sheathing. In one tower, a 3/4" airspace was left empty. In the other tower, the space was filled with foil-backed rigid foam insulation board. Indoor/outdoor thermometers were mounted on the north side of each tower with the "outdoor" probes inserted into the nest chambers.

Both towers were fitted with 4' x 4' kiosk panels on all sides. The kiosk panels and the lower half of the towers are sheltered by a roof. The roof and panels provide additional protection from the relentless Central Texas sun. In addition, the panels provide an ideal place to mount educational visual displays.

The location and the unique appearance of the towers make them highly visible to the many birders, school children and conservation groups that visit the facility. This new design lends itself well to placement in state parks and other public locations where an appeal for Chimney Swift conservation may be well received.
